Curling Rink Condition Assessment

August 2018

Associated Engineering along with Grace Architecture carried out a visual review of the Barrhead Curling Rink on June 15, 2018 with a focus to identify deficiencies and Alberta Building Code compliances within architectural, structural, mechanical and electrical systems.

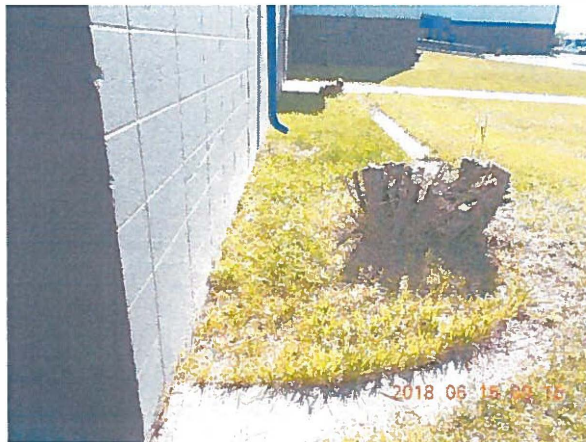
- The south grade appears to be sloped towards the building, and may be a location of ponding.
- The west wall has locations of scouring soil under partial height downspouts, with a missing downspout on the mechanical room.
- The grade along the west facing landscape begins just below the base of the exterior concrete block wall at the juncture with the foundation slab and is inconsistent in many places.
- The north grade of the structure has recently been replaced with a concrete apron to divert water west, but the drainage swale directly west has not been completed yet and is currently an area for ponding.

Figure 2-1
Viewing South Surface Grading

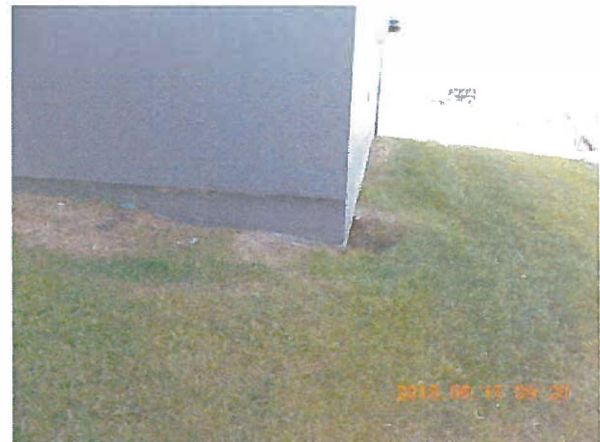
Figure 2-2
Viewing Scour from Missing Downspout of Mechanical Room

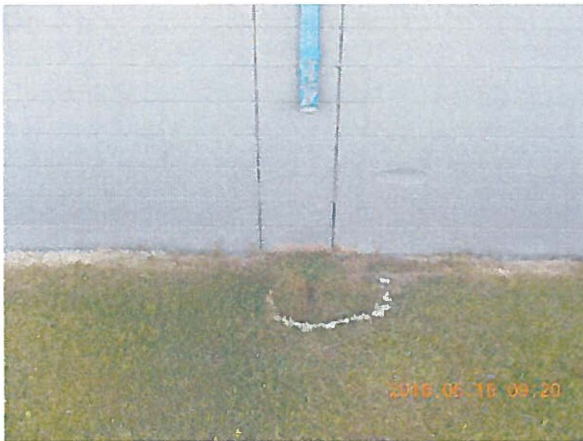
Figure 2-3
Viewing Scour on West Wall Surface Grading

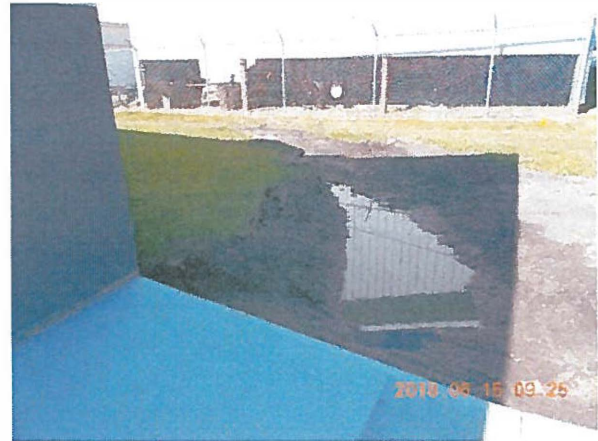
Figure 2-4
Viewing Incomplete Drainage Swale at NW Corner

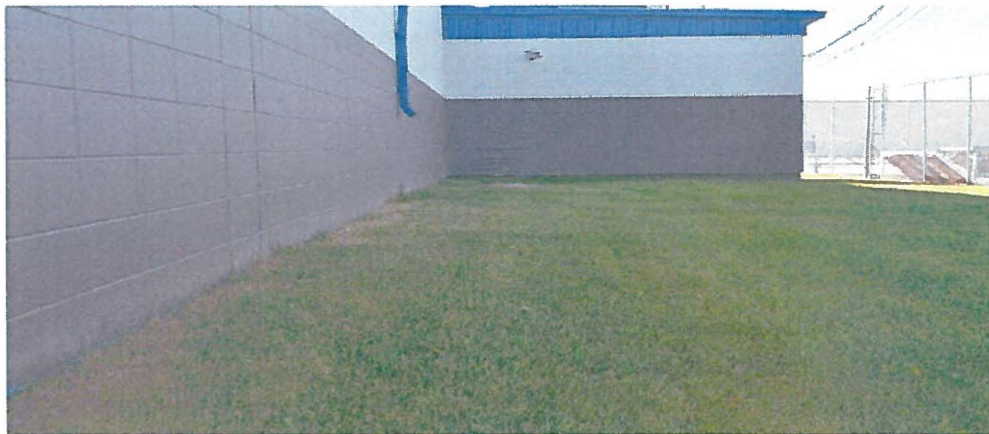
Insufficient grading can cause supersaturation of soils around and below the structure. Supersaturation can cause heaving of structural elements due to expansion of soils and frost.

Figure 2-5
Example of Inconsistent Grading at West Wall

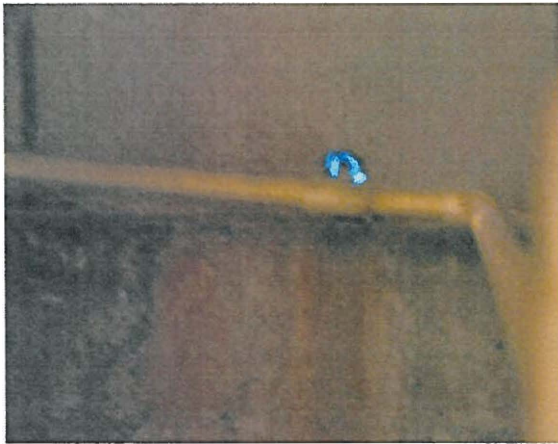
1. Daylight was observed around a pipe penetration through the exterior wall in the furnace room.
2. The paint and plywood on the exterior plywood sheathing of the ice plant is bubbling and warping.

Figure 3-1
Pipe Penetration Through the Exterior Wall
in Furnace Room

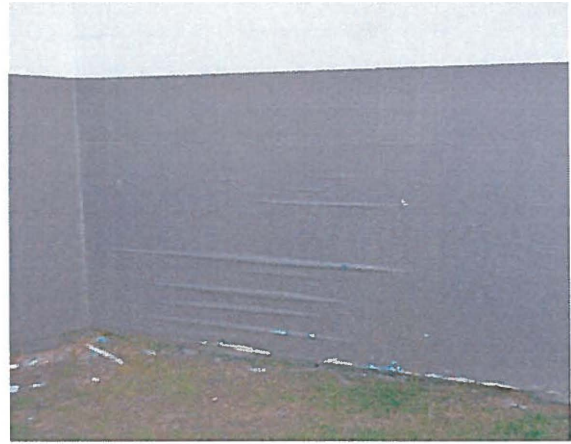
Figure 3-2
Paint and Plywood on Exterior
Plywood Sheathing

- Remove damaged exterior plywood and replace with exterior grade plywood and paint to match.
- Exterior doors and louvres: Remove flashing. Replace with new code compliant flashings and reglets. Add new head flashings on doors and louvres.
- Re-adhere existing rubber base at top of stair.
- Fill and patch bug hole and chipped locations in the masonry walls.
- Provide new sumps for improved drainage of thawed ice surfaces.
- Replace arena unit heaters at end of life within the next 10 years.
- Remove existing wall-prop exhaust fan and louver in the arena. Patch wall penetration.
- Replace furnaces at end of life, within the next five years. New furnaces to have fans run continuously during occupied periods and outside air rates to meet ASHRAE 62 guidelines.

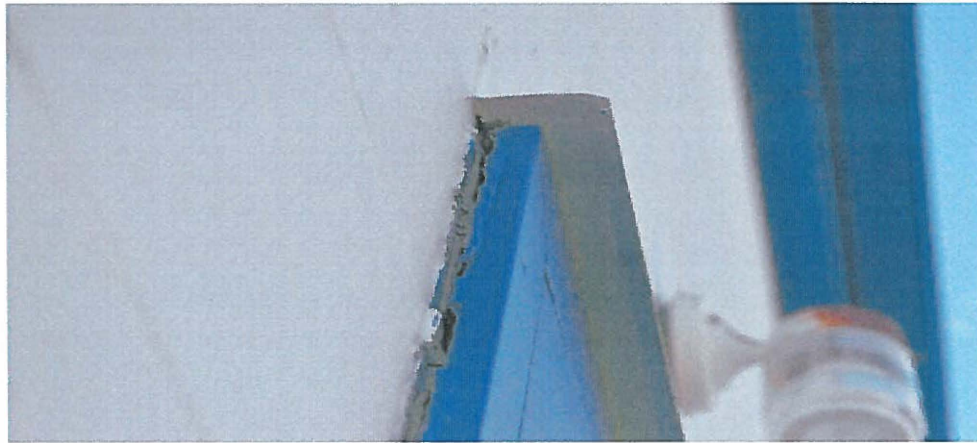
1. It was observed on site that the metal head flashings above the doors of northwest corner and southwest corner are surface mounted and do not have end damming. A gap between the exterior door trim and the concrete block wall has developed.

Figure 3-3
Metal Head Flashings Observed Above Doors of NW and SW Corners

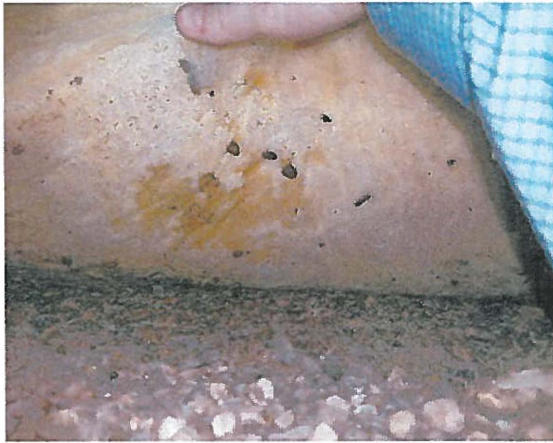
1. The staff had reported that water begins leaking from the ice surface ceiling during times of snow melt and heavier rains. This occurs primarily during the shoulder seasons but also during warming events in the winter months.
2. Drip staining on the underside of purlins (2017 Associated Engineering).
3. Water accumulation was observed in and beneath the batt insulation (2017 Associated Engineering).

Figure 3-4
Water Accumulation Observed In
and Beneath the Batt Insulation

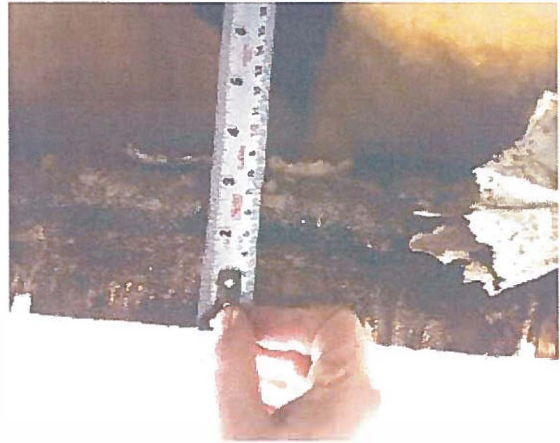
Figure 3-5
Jagged Saw Cut Opening in the Tongue and
Groove Wood Deck Along the East Wall

4. It was observed on site that there is a jagged saw cut opening in the tongue and groove wood deck along the east wall.

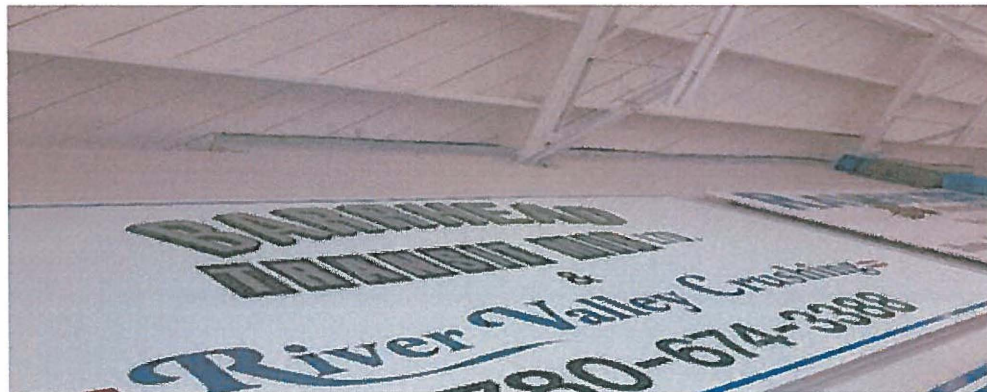
Figure 3-6
Jagged Saw Cut in Wood Deck

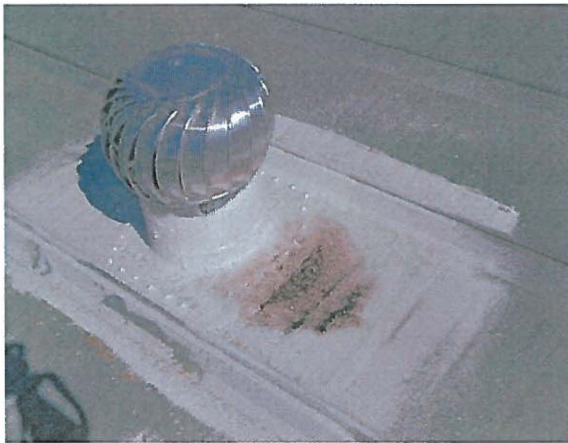
5. It was observed that the roof vents did not have adequate cribbing and slope to prevent ponding.
6. It was observed that some flashing seams were not sealed and fastened.

Figure 3-7
Roof Vents with Evidence of Ponding

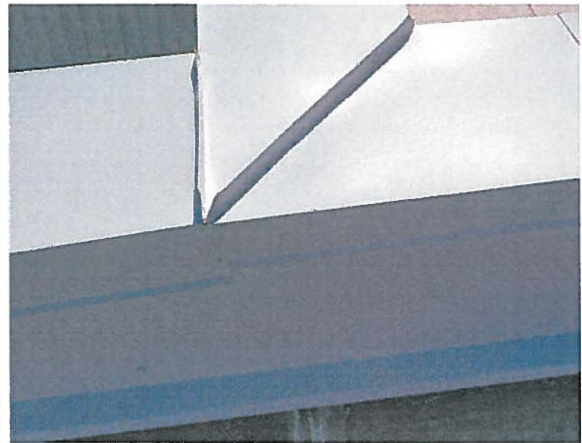
Figure 3-8
Flashing Seams Not Sealed and Fastened

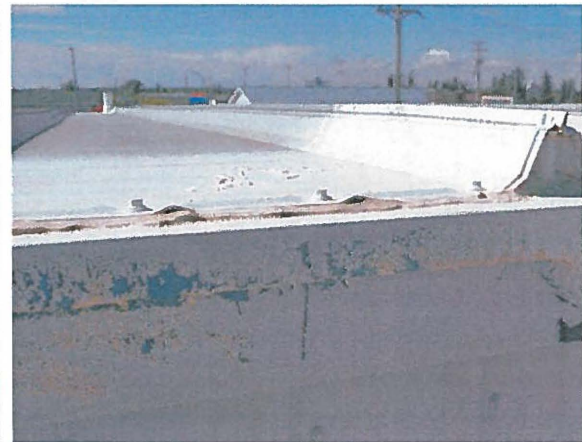
Figure 3-10
**Sealant on Leading Edge of Concession Roof
Deteriorated and Separated from Flashing**

7. The sealant on the leading edge of the concession roof has deteriorated and separated from the flashing.
8. It was observed that a downspout was missing on the northwest corner of the Ice Plant extension.

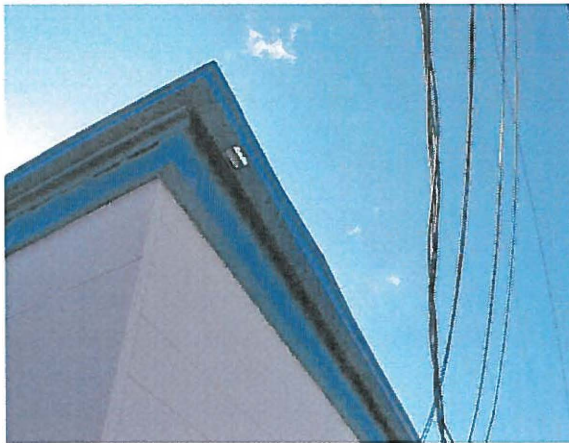
Figure 3-11
Downspout Missing on NW Corner of Ice Plant Extension

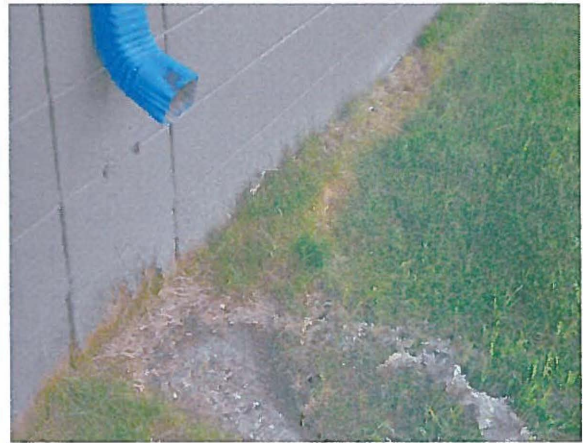
Figure 3-12
Existing Downspout Not Extended to Grade

9. The existing downspouts do not extend to grade and there are no splash pads in place to prevent erosion of the landscaping at the foundations and to divert water away from building foundations.

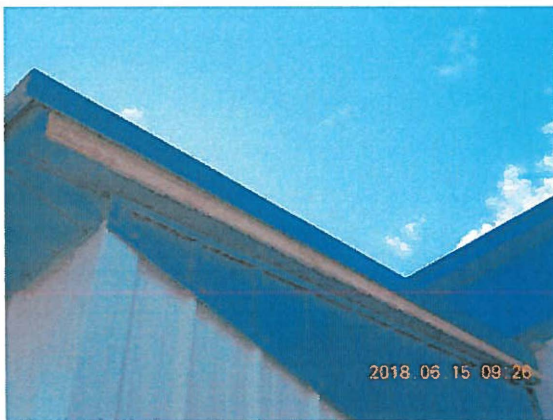
Figure 3-13
Missing Material on Storage Room Roof

10. The west side of the roof of the storage addition is missing waterproofing membrane and metal fascia to protect wood fascia board. The fascia drip flashing is not sufficient by itself to divert water away from the wall surface. J-trim is missing to secure the metal soffit.
11. Flashing panel was removed on the north wall to provide ventilation, but this exposes the interior to the weather.

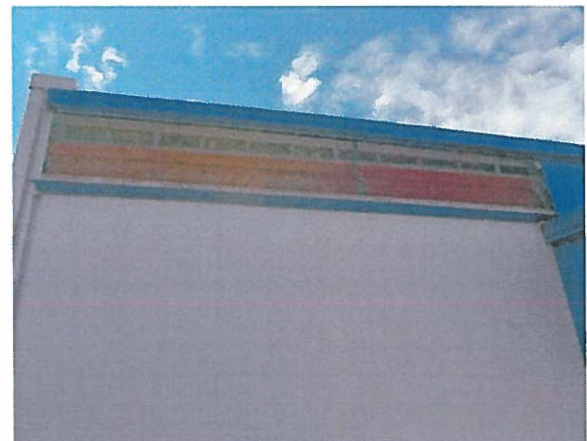
Figure 3-14
Missing Fascia Panel on North Wall

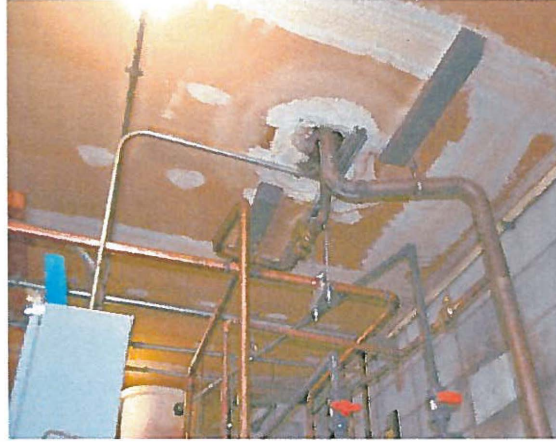
12. Water damage was observed on the ceiling in the Ice Plant around the roof penetrations.

Figure 3-15
Water Damage to Ice Plant Ceiling

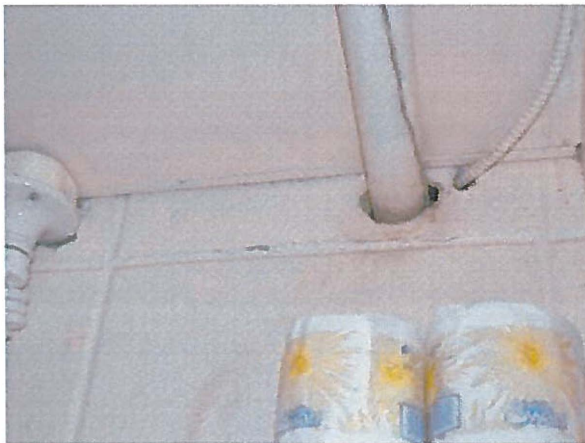
Figure 3-16
Fire Seal Required at Wall Penetration

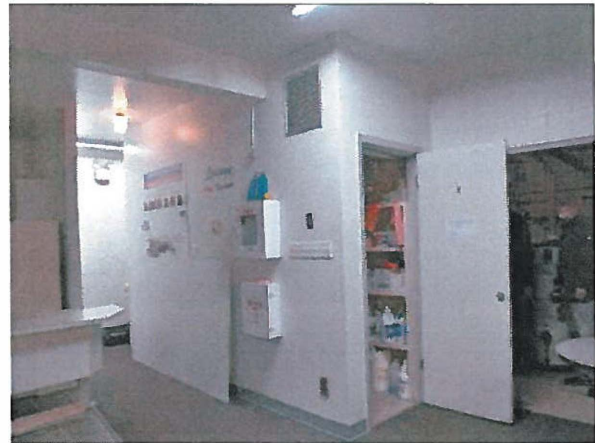
1. Fire separation of Janitor's storage closet beneath the mezzanine stairs must be not less than one hour, in accordance with ABC 2014, Section 3.3.1.21 Janitor's Rooms.
 1. The existing door and frame is not fire rated.
 2. Penetrations are not fire stopped and fire sealed in accordance with ABC 2014, Section 3.1.9 Penetrations in Fire Separations and Fire Rated Assemblies.

Figure 3-17
Viewing Janitor's Storage Closet

- Provide 1hr fire separation of Janitor's storage room beneath stairs.
 - Replace existing doors with new 3/4 hour fire rated door, frame, and hardware to meet Building Code requirements.

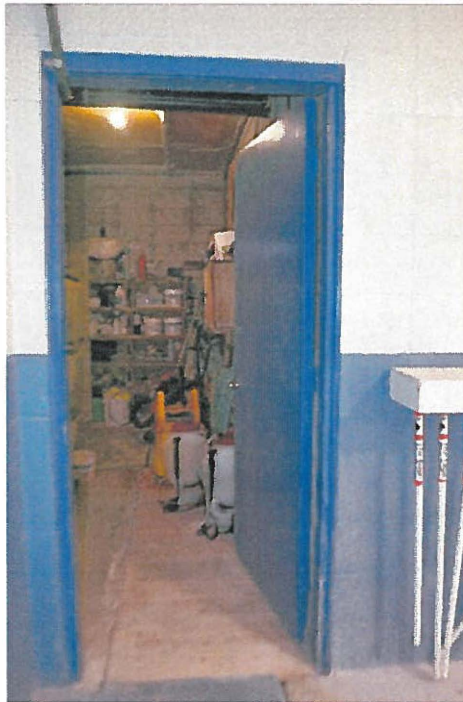
Figure 3-18
Viewing Ice Plant Room Door

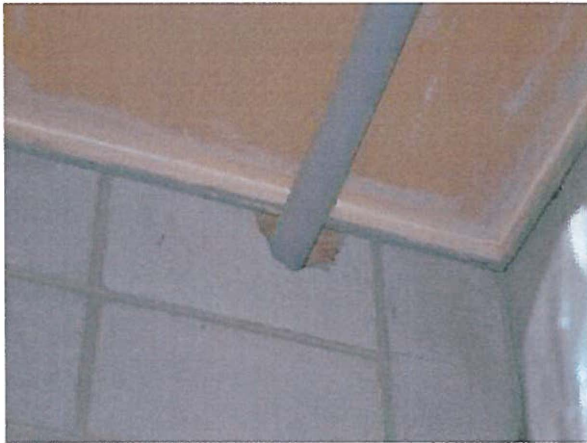
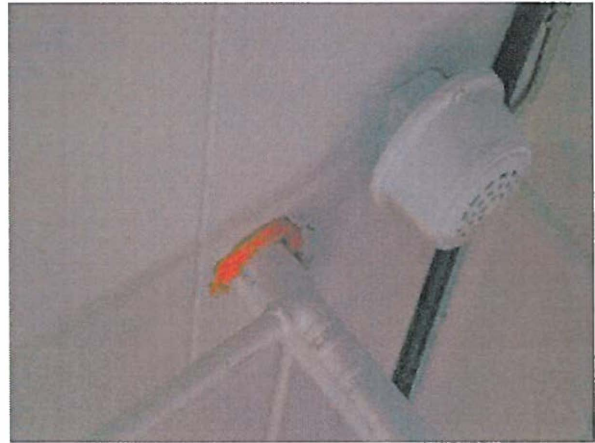
3. Penetrations are not fire stopped and fire sealed in accordance with ABC 2014, Section 3.1.9 Penetrations in Fire Separations and Fire Rated Assemblies.

Figure 3-19
Example of Penetration Requiring Fire Sealant

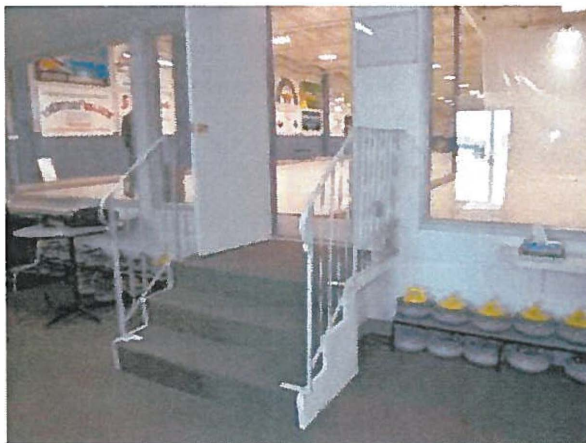
1. There is no exit sign visible on approach from the top of stair to indicate during an emergency the location of the exit door to the right, at the base of stair in accordance with ABC 2014, Section 3.4.5.1 Exit Signs.
2. Ice surface exit stair to the lower viewing area does not have code compliant railing in accordance with ABC 2014, Section 3.4.6.5 Handrails.
3. Ice surface exit ramps at the northeast exit door do not have railings and guards. The platform at the top of the ramp is not sized in accordance with ABC 2014, Section 3.8.3.4 Ramps.

Figure 3-21
Ice Surface Exit Stair to Lower Viewing Area

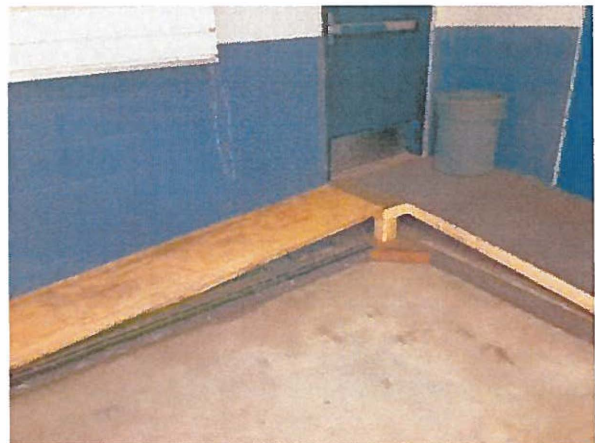
Figure 3-22
Ice Surface Exit Ramps at NE Exit Door

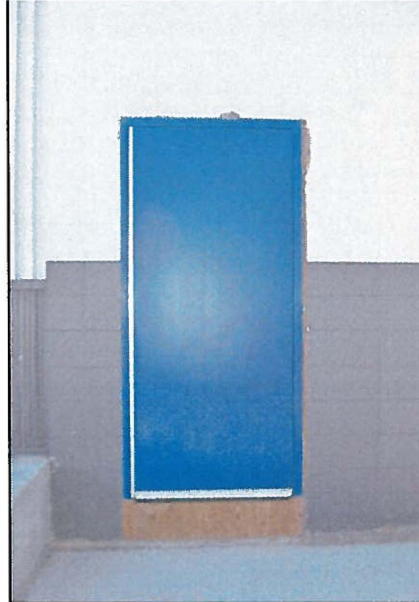
4. Ice surface northeast exit door has no exterior landing and step to ground level.

Figure 3-23
NE Exit Door

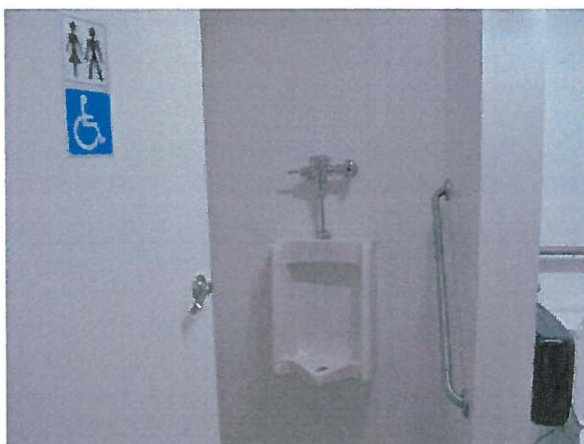
1. Wall and floor surfaces around the washroom urinal are not protected with impervious and durable material in accordance with ABC 2014, Section 3.7.2.6, Surface Protection.

Figure 3-24
Men's Washroom – Wall Surface Around
Washroom Urinal

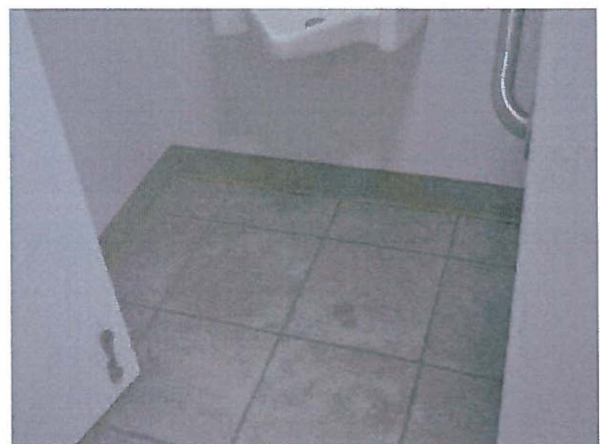
Figure 3-25
Men's Washroom – Floor Surface Around
Washroom Urinal

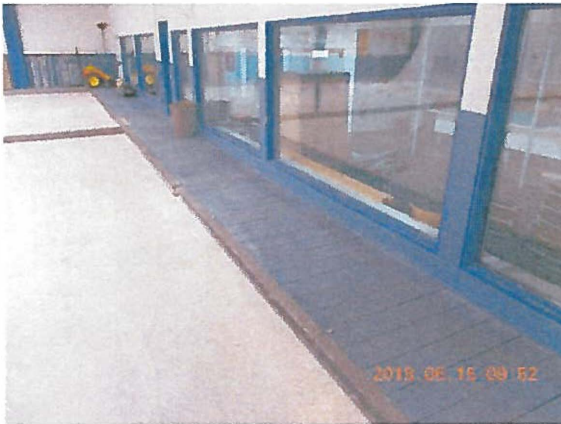
Header trenches are located at each end of the playing sheets and covered with wood planking. Most planked areas were anchored down with exception to the southwest corner. It was noticed that the bottom of the trench was covered in a heavy dried-out paste which was likely the coloring used during ice construction. The concrete side walls appeared to be in fair condition.

Figure 4-1
Viewing South Header Trench

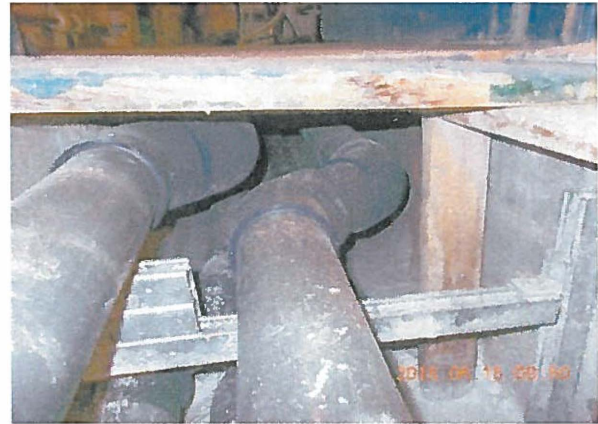
Figure 4-2
Viewing Inside Header Trench

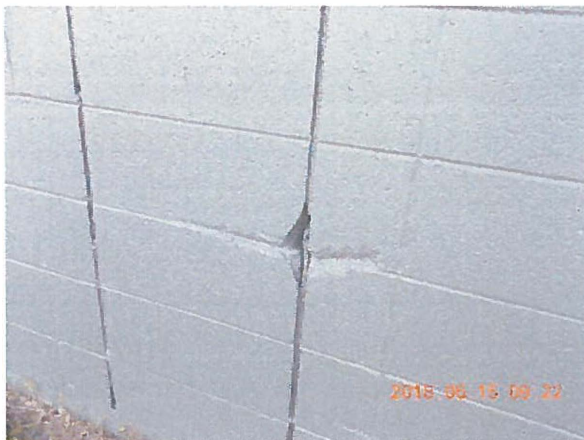
- The masonry walls had a recent painted finish, no cracks were visible.
- The expansion joints of the west wall have lost most fill material and sealant. Joints should be repacked and sealed to prevent moisture and contaminant ingress including pests and debris.
- A few chips and bug hole voids were visible on the exterior surfaces.
- Drainage from partial height down spouts appears to be saturating the nearby wall surface and causing surface deterioration likely due to freeze-thaw.
- The exterior surface of the centerline beam pocket of the north is protruding. This area should be investigated to determine if it was constructed in this manner, or the beams are applying pressure to the wall.

Figure 4-3
Viewing Chip at Expansion Joint

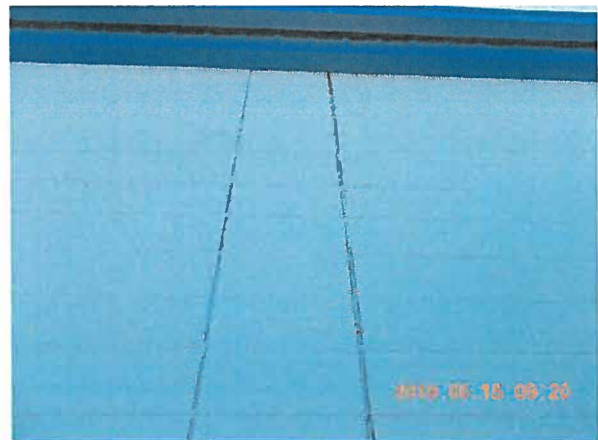
Figure 4-4
Viewing Condition of Expansion Joints

- Install backing and seal the masonry expansion joints to prevent moisture and contaminant ingress including pests and debris.
- Investigate cause of masonry centerline beam pocket on north wall and repair to match face of exterior wall.

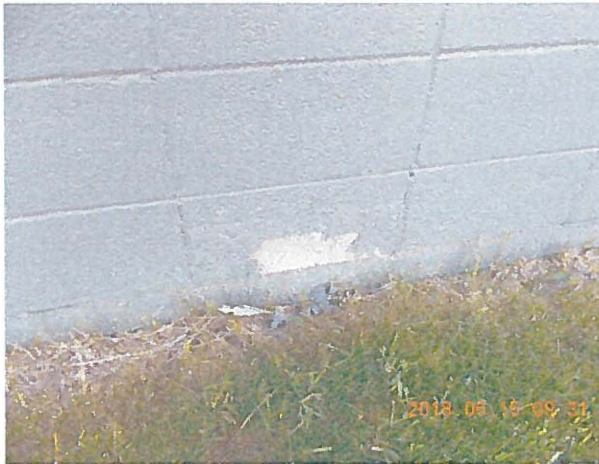
Figure 4-5
Viewing Saturation from Downspout with
Freeze Thaw Deterioration

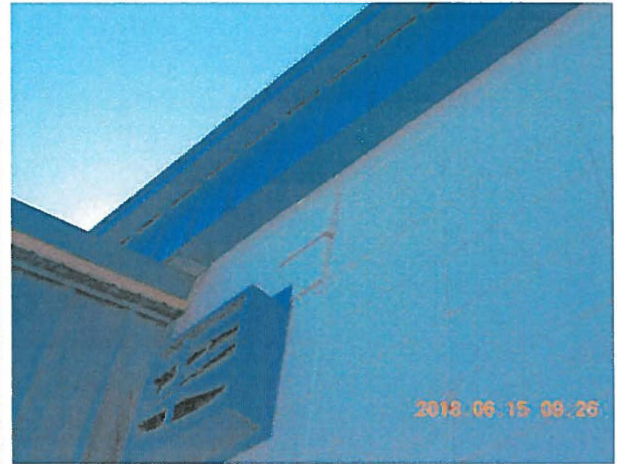
Figure 4-6
Viewing North Beam Pocket Protruding Blocks

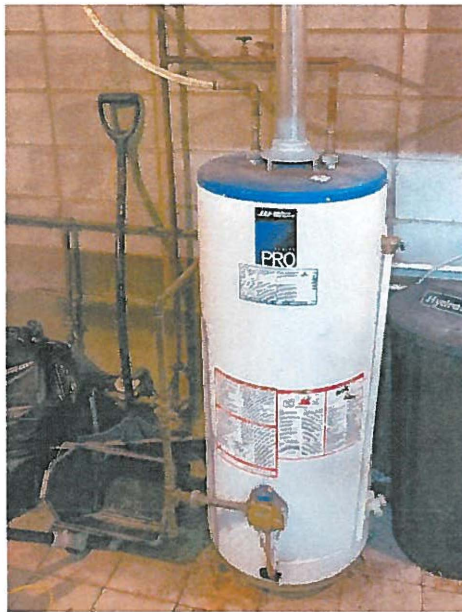
The domestic water system is piped with copper piping and fittings, which generally appear to be in good condition. The domestic hot and cold piping are not insulated. Adding insulation would be beneficial on cold piping to minimize development of condensation as well as on hot piping to reduce the load on the domestic water heater. However, this action should be considered optional as the energy savings will not be large enough to offset the cost of additional insulation.

Figure 5-1
Domestic Water Heater and Piping. Water Meter
Behind Debris

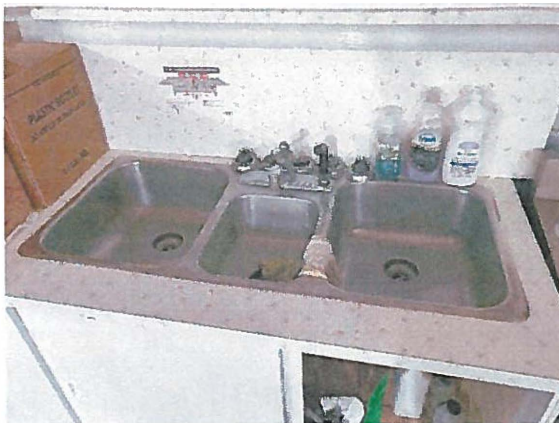
Figure 5-2
Dated Three-Compartment Sink Fixture

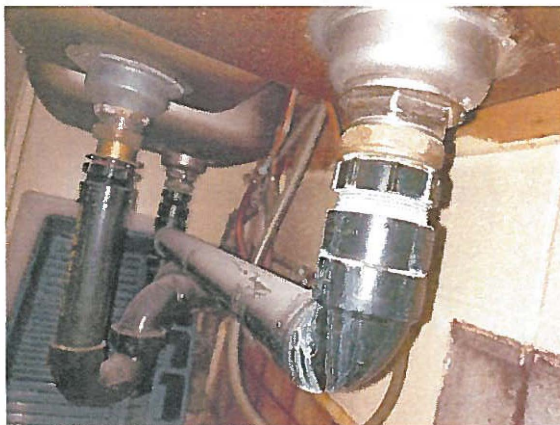
Figure 5-4
Sanitary Drainage from Three-Compartment Sink
is Missing a Grease Interceptor

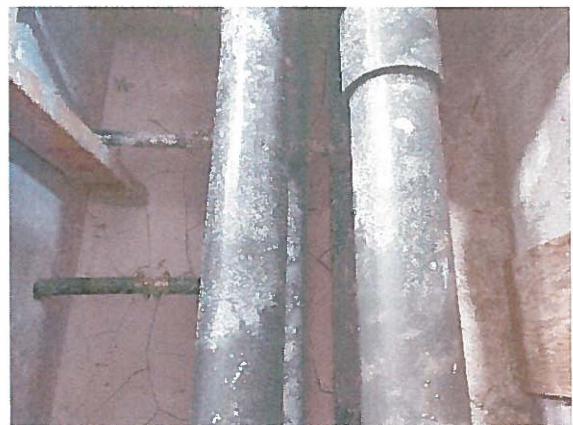
Figure 5-5
Header Trench Piping Coated in White Powder;
Dry and Cracked Sediment Layer at Trench
Bottom

To resolve slow drain times for the ice surfaces, installing a new interceptor on the drain line from the header trench is recommended to intercept paint and sediment from the ice surfaces. It may not be possible to locate the interceptor within the header trench since the large amount of permanent piping within the trench would make installation and maintenance for the interceptor challenging, if not impossible. Instead, the interceptor can be located somewhere inside the foyer area where access is more convenient. The exact location of the buried sanitary line is not known so line locating will need to be performed to identify the best interceptor location. At this time, the resizing of the drain line should be considered to properly handle the large flow volume that occurs during the thaw cycle, however, this would present significant additional costs that have not been included in the recommendations summary.

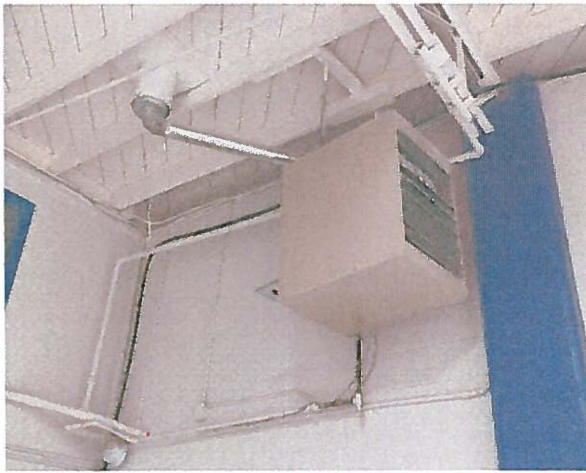
The arena area of the building is heated by two Lennox unit heaters, installed approximately nine years ago. The unit heaters appear to be in good condition and are about halfway through their service life. As per recommendations made in the previous assessment report, these unit heaters should be replaced with sealed-combustion units at the end of their life as there is currently no combustion air provided to the heaters. The flues for the unit heaters are showing evidence of corrosion and have been partially painted over. It is not recommended to paint over corrosion unless the surfaces have first been properly prepared, or corrosion will continue to occur. The flues should be replaced with a corrosion-resistant material such as CPVC or stainless steel when the unit heaters are replaced for better longevity of the flues.

Figure 5-7
West Unit Heater Missing Combustion Air Duct

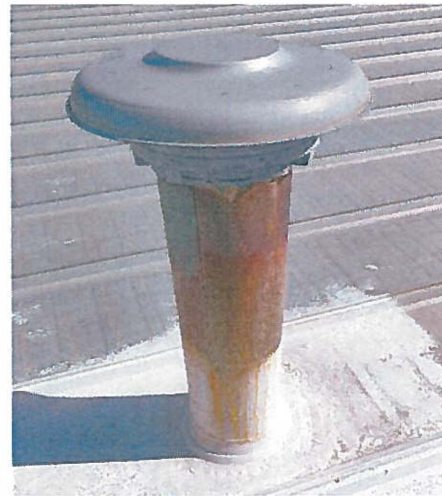
Figure 5-8
Corroded Flue for West Unit Heater Painted Over

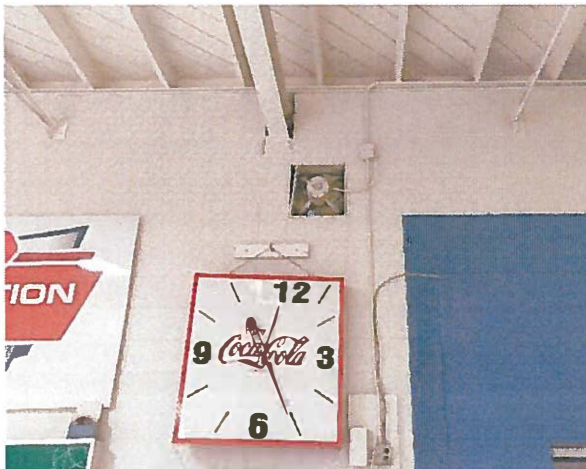
A propeller fan installed in the north wall to ventilate the space is currently not operational. The motorized damper associated with the ventilation fan does not seal properly and is not operational. The fan and damper should be removed and the wall penetration patched.

Figure 5-9
Existing Non-Operational Propeller Fan

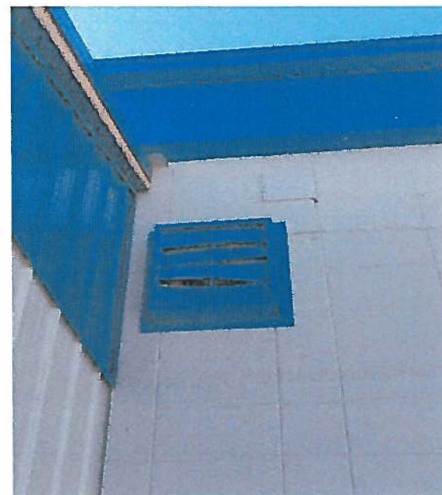
Figure 5-10
Damaged Motorized Damper for Propeller Fan

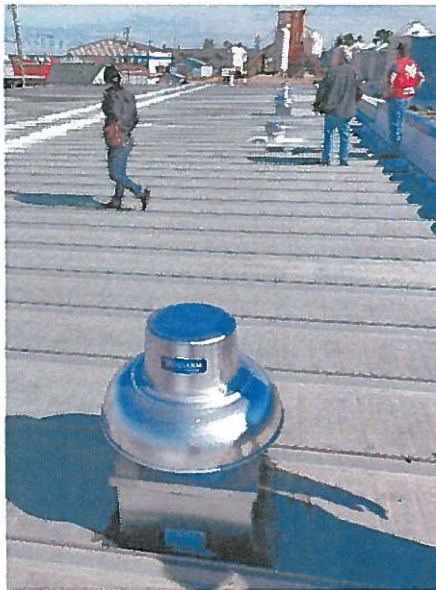
Following the recommendations of the previous assessment report, two Canarm ALX-120 DD fan-powered vents were installed in the roof to combat moisture concerns within the roof attic space. Currently, there are two fan-powered and three passive roof vents installed to ventilate the attic. It is apparent that the moisture issue was not solved as there was water dripping from the arena ceiling last winter. The recommendations provided in the architectural and structural reports should be followed to properly repair the roof assembly and separate the attic space from the arena to prevent humidity from the arena entering the attic space. Additional mechanical roof venting is not recommended until the repair work discussed in the architectural section of this report has been completed.

Figure 5-11
Current Roof Venting: Two Fan Powered Vents
and Three Passive Vents

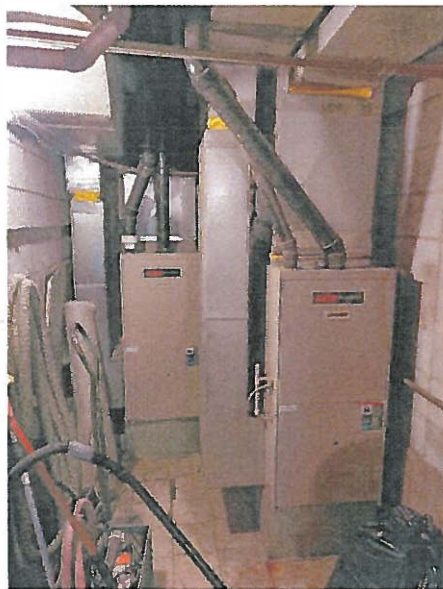
Each floor of the common areas is served by a Lennox G26 gas-fired furnace. The previous assessment report had indicated three concerns with the furnace venting, none of which appears to have been completed. To re-iterate the deficiencies noted in the previous report, the existing ABS-DWV furnace vents are not suited for use in a gas flue and should be replaced with ULC-S636 certified pipe and fittings; pipe penetrations of fire-rated walls should be equipped with ULC-approved fire stopping device or replaced with an approved system listed under CAN/ULC-S115; finally, the separation distance between the furnace combustion air and flue exhaust vents at the exterior of the building should be increased to meet the Natural Gas Installation Code CSA B149.1.

Figure 5-12
Furnaces with ABS Venting
in Furnace Room

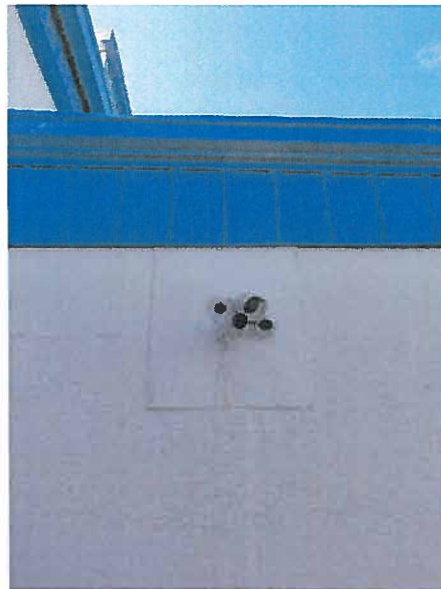
Figure 5-13
No Separation Distance
on Furnace Vents

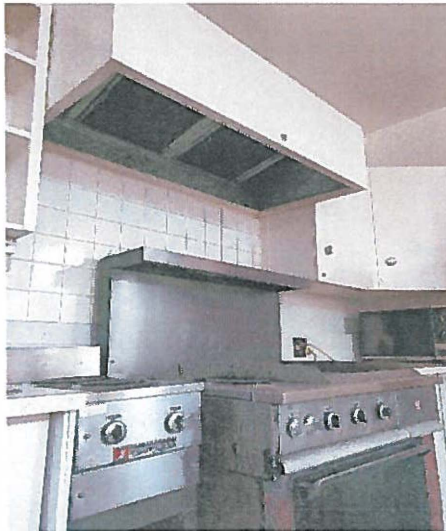
Figure 5-14
Commercial Kitchen Range Hood
Missing Fire Suppression System

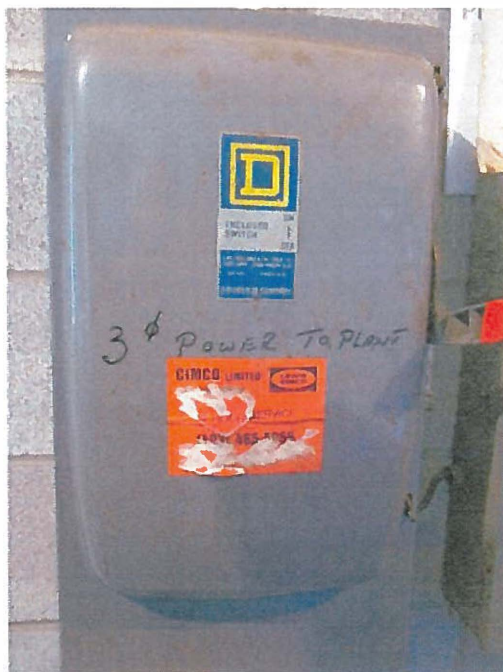
The two main disconnects appear original and in working order though they were not tested for functionality. The ice plant main disconnect was in the open position at the time of the site visit. Upon visual inspection of the ice plant main disconnect, it appears to have had electrical issues based on the black substance inside and on the exterior of the disconnect. It also appears that one of the fuses has blown in the past. It is strongly recommended an assessment of the ice plant load be completed to ensure the disconnect is sized as per Canadian Electrical Code (CEC) and that the disconnect is replaced with new.

Figure 6-2
120/208V, 3 Phase, 200A Main Disconnect

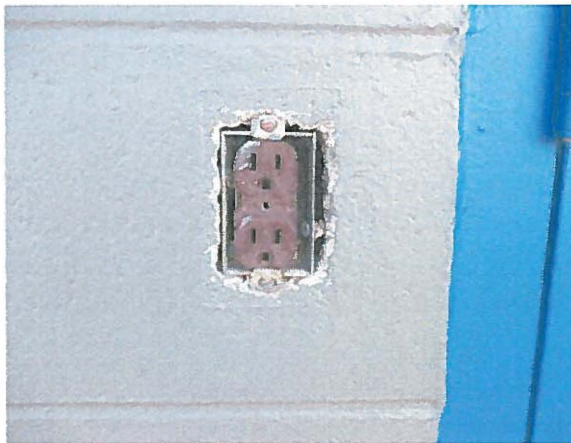
There were multiple instances of the current CEC not being met. Exterior outlets were standard outlets without any weather protection. All exterior outlets must have a weatherproof cover and either be a GFCI receptacle or protected by a GFCI breaker to meet CEC requirements. The existing receptacle near the kitchen sink does not have GFCI protection, which is required to meet CEC. Several electrical receptacles in the curling rink are missing cover plates. All receptacles must have a cover plate installed to meet CEC requirements. It is also recommended installing a weatherproof cover for all receptacles located in the ice rink as they could be splashed with water when ice is being made.

Figure 6-6
Exterior Receptacle Needing Repair

- Replace the water heater with a new direct-vented unit.
- Install GFI breaker in Panel A for exterior outlets.
- Repair exterior receptacles and Curling Rink receptacles.

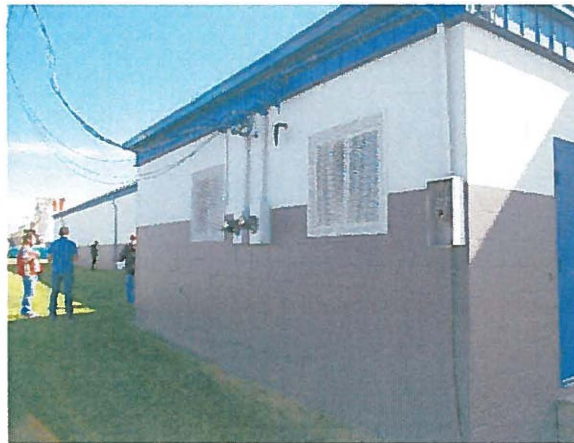
Figure 6-7
Utility Feeds & Abandoned Utility Feed

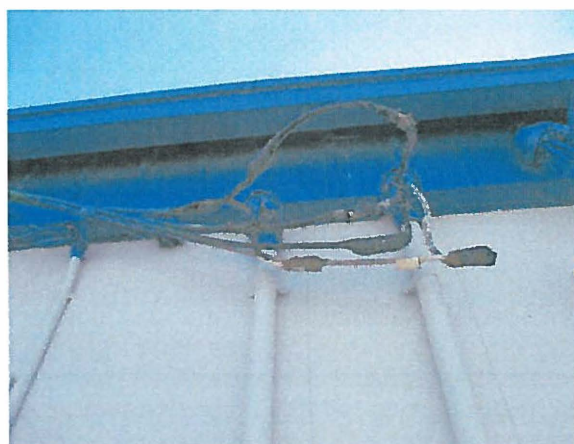
Figure 6-8
Utility Feed Splice Requiring Repair

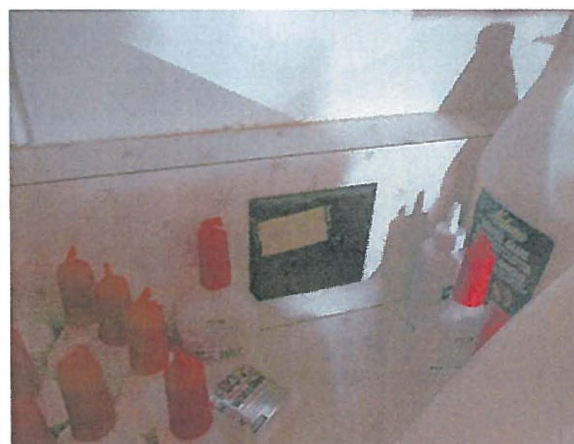
Figure 6-9
Regular Receptacle in Kitchen by Sink

- Replace one existing kitchen receptacle with GFCI receptacle.

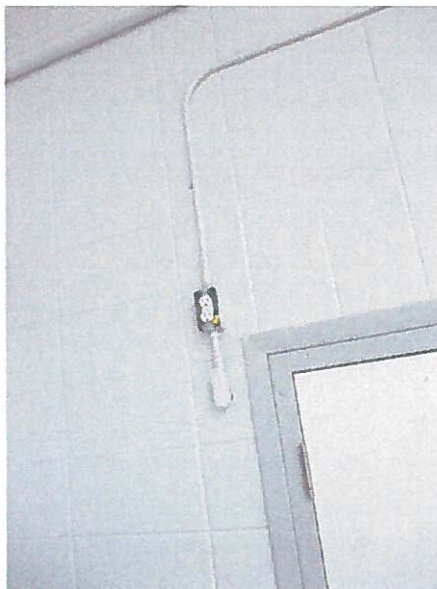
Figure 6-10
Receptacle Missing Plate in Curling Rink

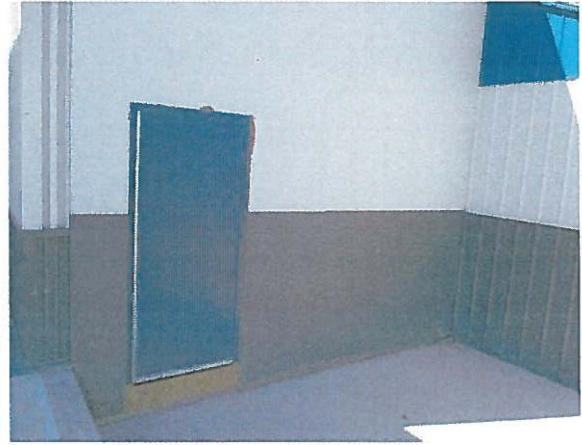
Figure 6-12
No Exterior Light by NE Exit Door

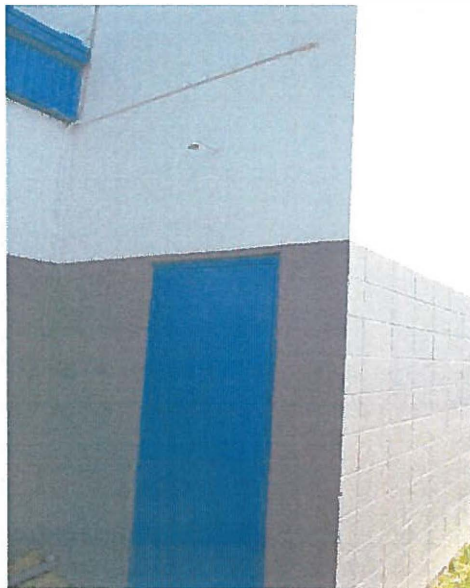
Figure 6-13
Exterior Bulb and Cover Missing (SW Corner)

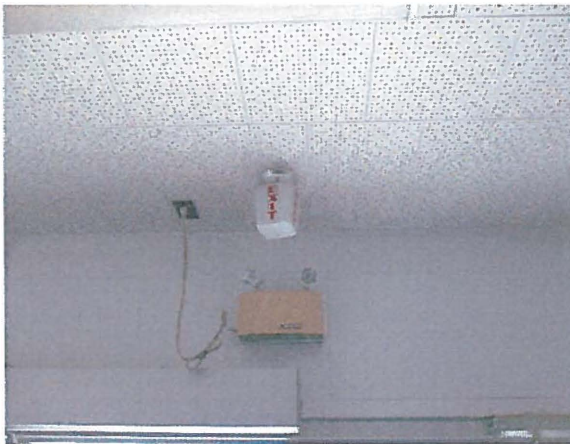
Existing exit signs are a mix of various types. To be consistent throughout the building, it is recommended to replace all exit signs with green "running man" style signs to meet Section 9.9.11.3 (2)(b) of the Building Code.

Figure 6-15
Dated Exit Signs

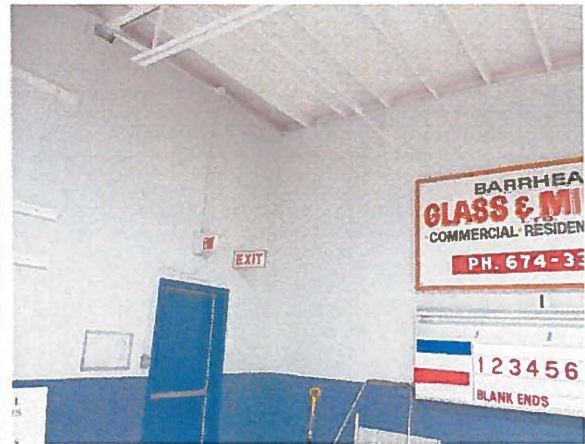
Figure 6-16
Emergency Light Not Installed by NW Exit
