Curling Rink Condition Assessment

August 2018

Associated Engineering along with Grace Architecture carried out a visual review of the Barrhead Curling Rink on June 15, 2018 with a focus to identify deficiencies and Alberta Building Code compliances within architectural, structural, mechanical and electrical systems.

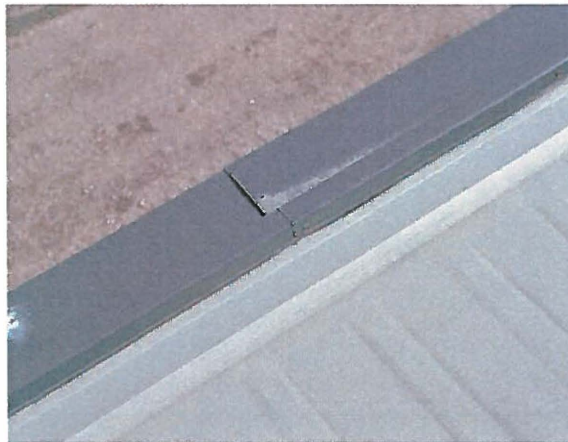
Figure 3-9
Flashing Seams Not Sealed and Fastened

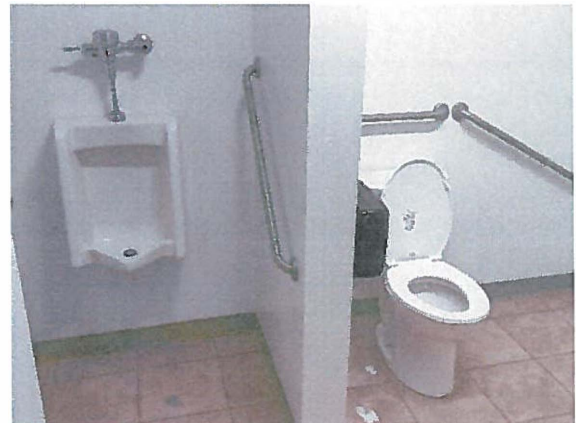
Figure 5-3
Renovated Washroom Fixtures

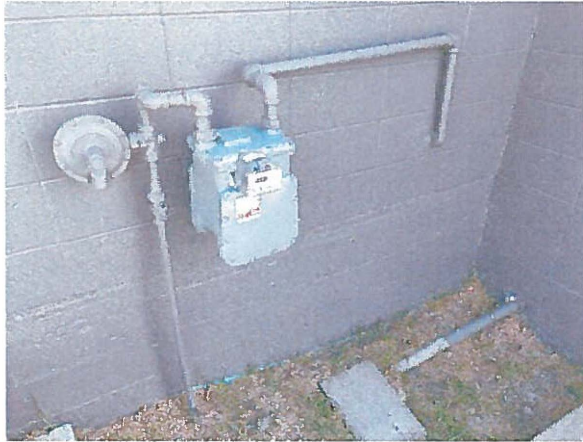
The gas meter and regulator set that provides natural gas to the building is located on the west exterior wall, just outside the furnace room. The gas piping supplying the furnaces, water heater and unit heaters is painted and appears to be in good condition. No required repairs or upgrades were identified for the gas system.

Figure 5-6
Gas Meter and Regulator Mounted on
West Side of Building

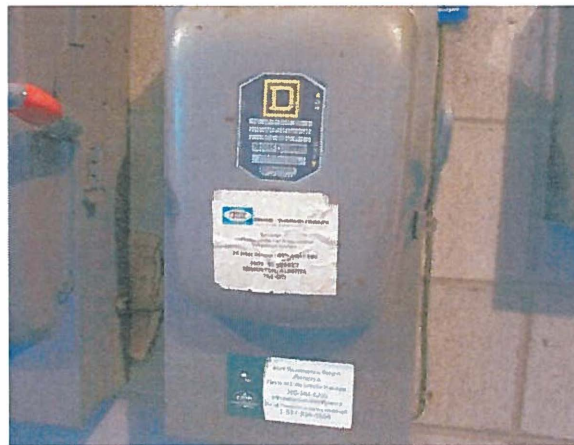
The two main disconnects appear original and in working order though they were not tested for functionality. The ice plant main disconnect was in the open position at the time of the site visit. Upon visual inspection of the ice plant main disconnect, it appears to have had electrical issues based on the black substance inside and on the exterior of the disconnect. It also appears that one of the fuses has blown in the past. It is strongly recommended an assessment of the ice plant load be completed to ensure the disconnect is sized as per Canadian Electrical Code (CEC) and that the disconnect is replaced with new.

Figure 6-1
120/208V, 1 Phase 200A Main Disconnect

The electrical system appears in working order but is at the end of its useful life and replacement parts may be costly or hard to find. It is recommended to replace the two main disconnects with new, especially the disconnect for the ice plant. The utility wiring splices by the utility weatherhead should be inspected as the splices have been damaged and are not properly sealed from the elements. The weatherhead is located on the southwest side of the building.

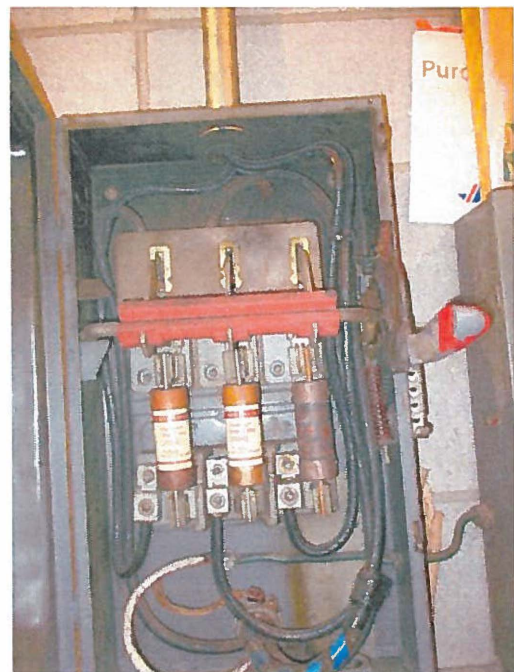
Figure 6-3
Inside 120/208V, 3 Phase, 200A Main Disconnect

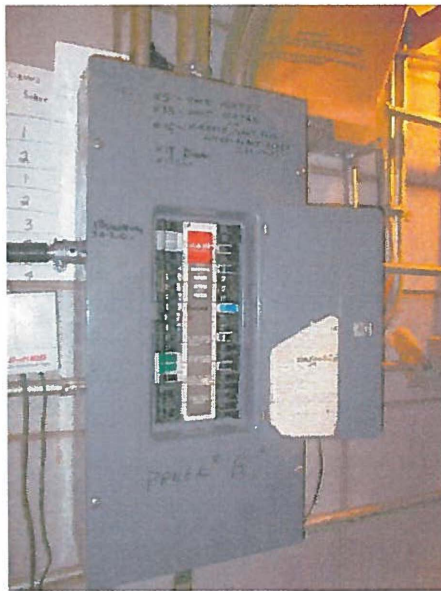
**Figure 6-4
Panel A**

Panel A, located in the furnace room, provides 120/208V single phase power throughout the building. A new sub panel, Panel B, has been installed in the furnace room.

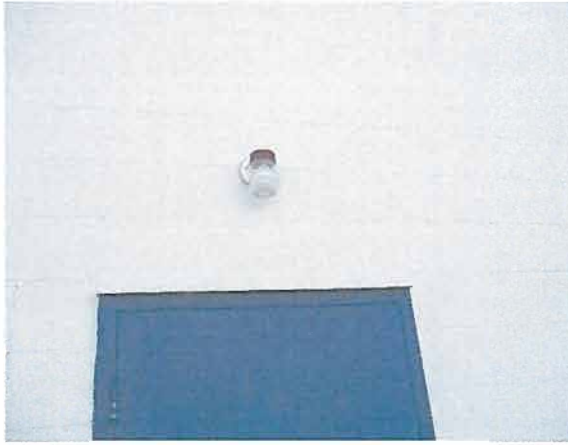
All exterior lights are turned on manually, except for one newer light at the entrance. Existing lights are damaged or in poor condition and past their life expectancy. It is recommended the exterior lighting be replaced with LED fixtures to match the newer light by entrance. This will provide better and more uniform lighting on the exterior. LED fixtures can have a built-in photocell to allow for automatic control and energy savings. It is also recommended adding an exterior light by northeast exit door as the door is almost one foot above the ground and adequate lighting will increase safety.

Figure 6-11
Exterior Lights

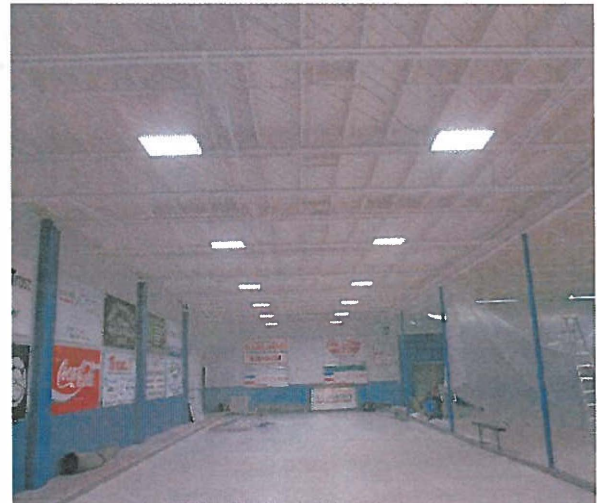
Figure 6-14
New LED Lighting in Curling Rink
